# Historical Coastal Change at Sunderland Point

Our Future Coast is using historical data to understand the long-term patterns of coastal change at our sites. This document captures the results of the research into Sunderland Point.

Produced by Claire Bradshaw, Archaeology & Heritage Officer,  
Morecambe Bay Partnership

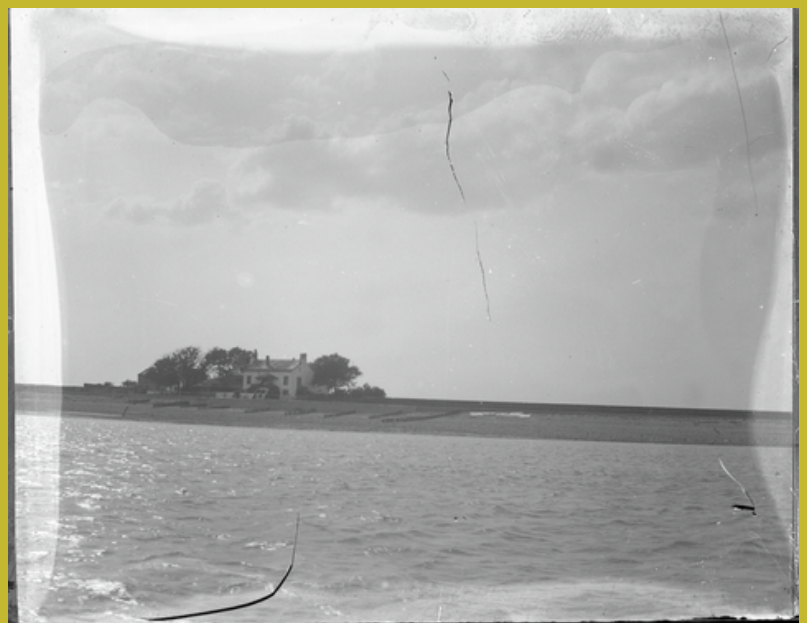
Fig. 11 Photo of the groyne outside of the Old Hall, around 1900. Lancashire Red Rose Collections

The wall could also have played a part in the 1910 accumulation of saltmarsh between Old Hall and Second Terrace. It is also worth noting that this map shows that groyne had been placed just north of Old Hall by this time, which would also have changed sediment movement.

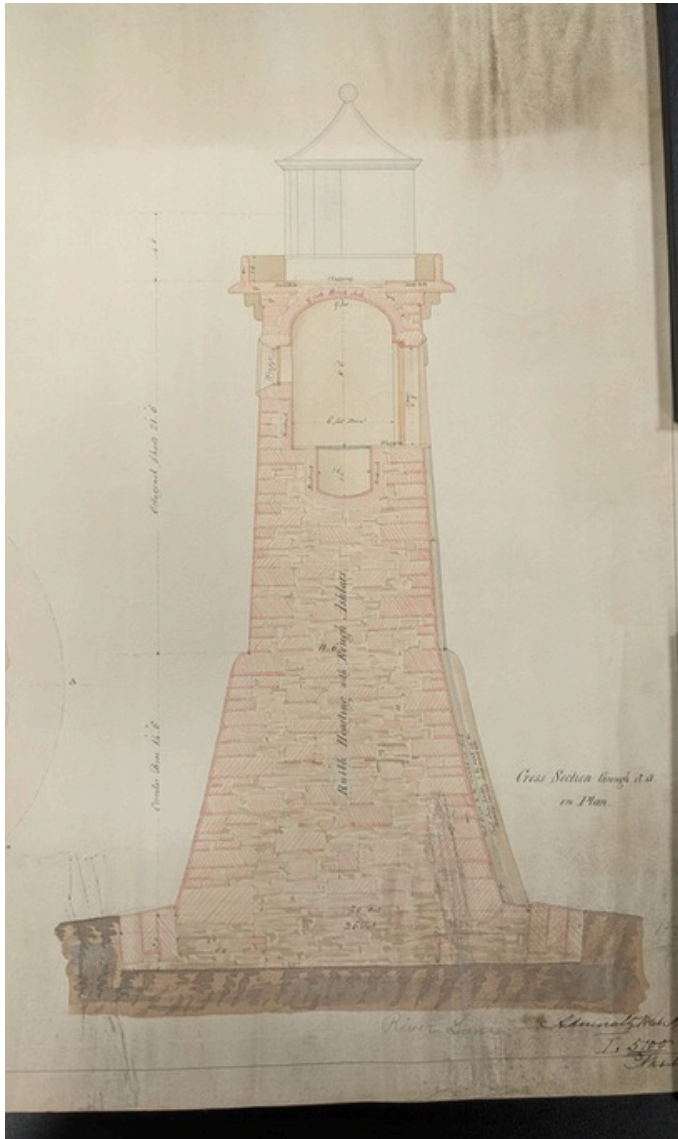
Fig. 19 Design for proposed lighthouse in the Lune channel, 1851. Lancashire Archive Service BOT/316.

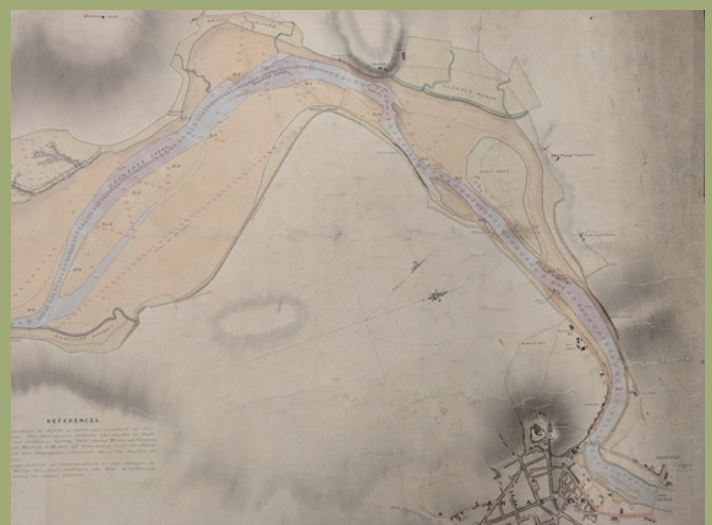
Fig. 27 Extract from Stevenson's depth survey of the River Lune from Lancaster to Glasson, 1838. Lancashire Archive Service NWW/1/2/4.

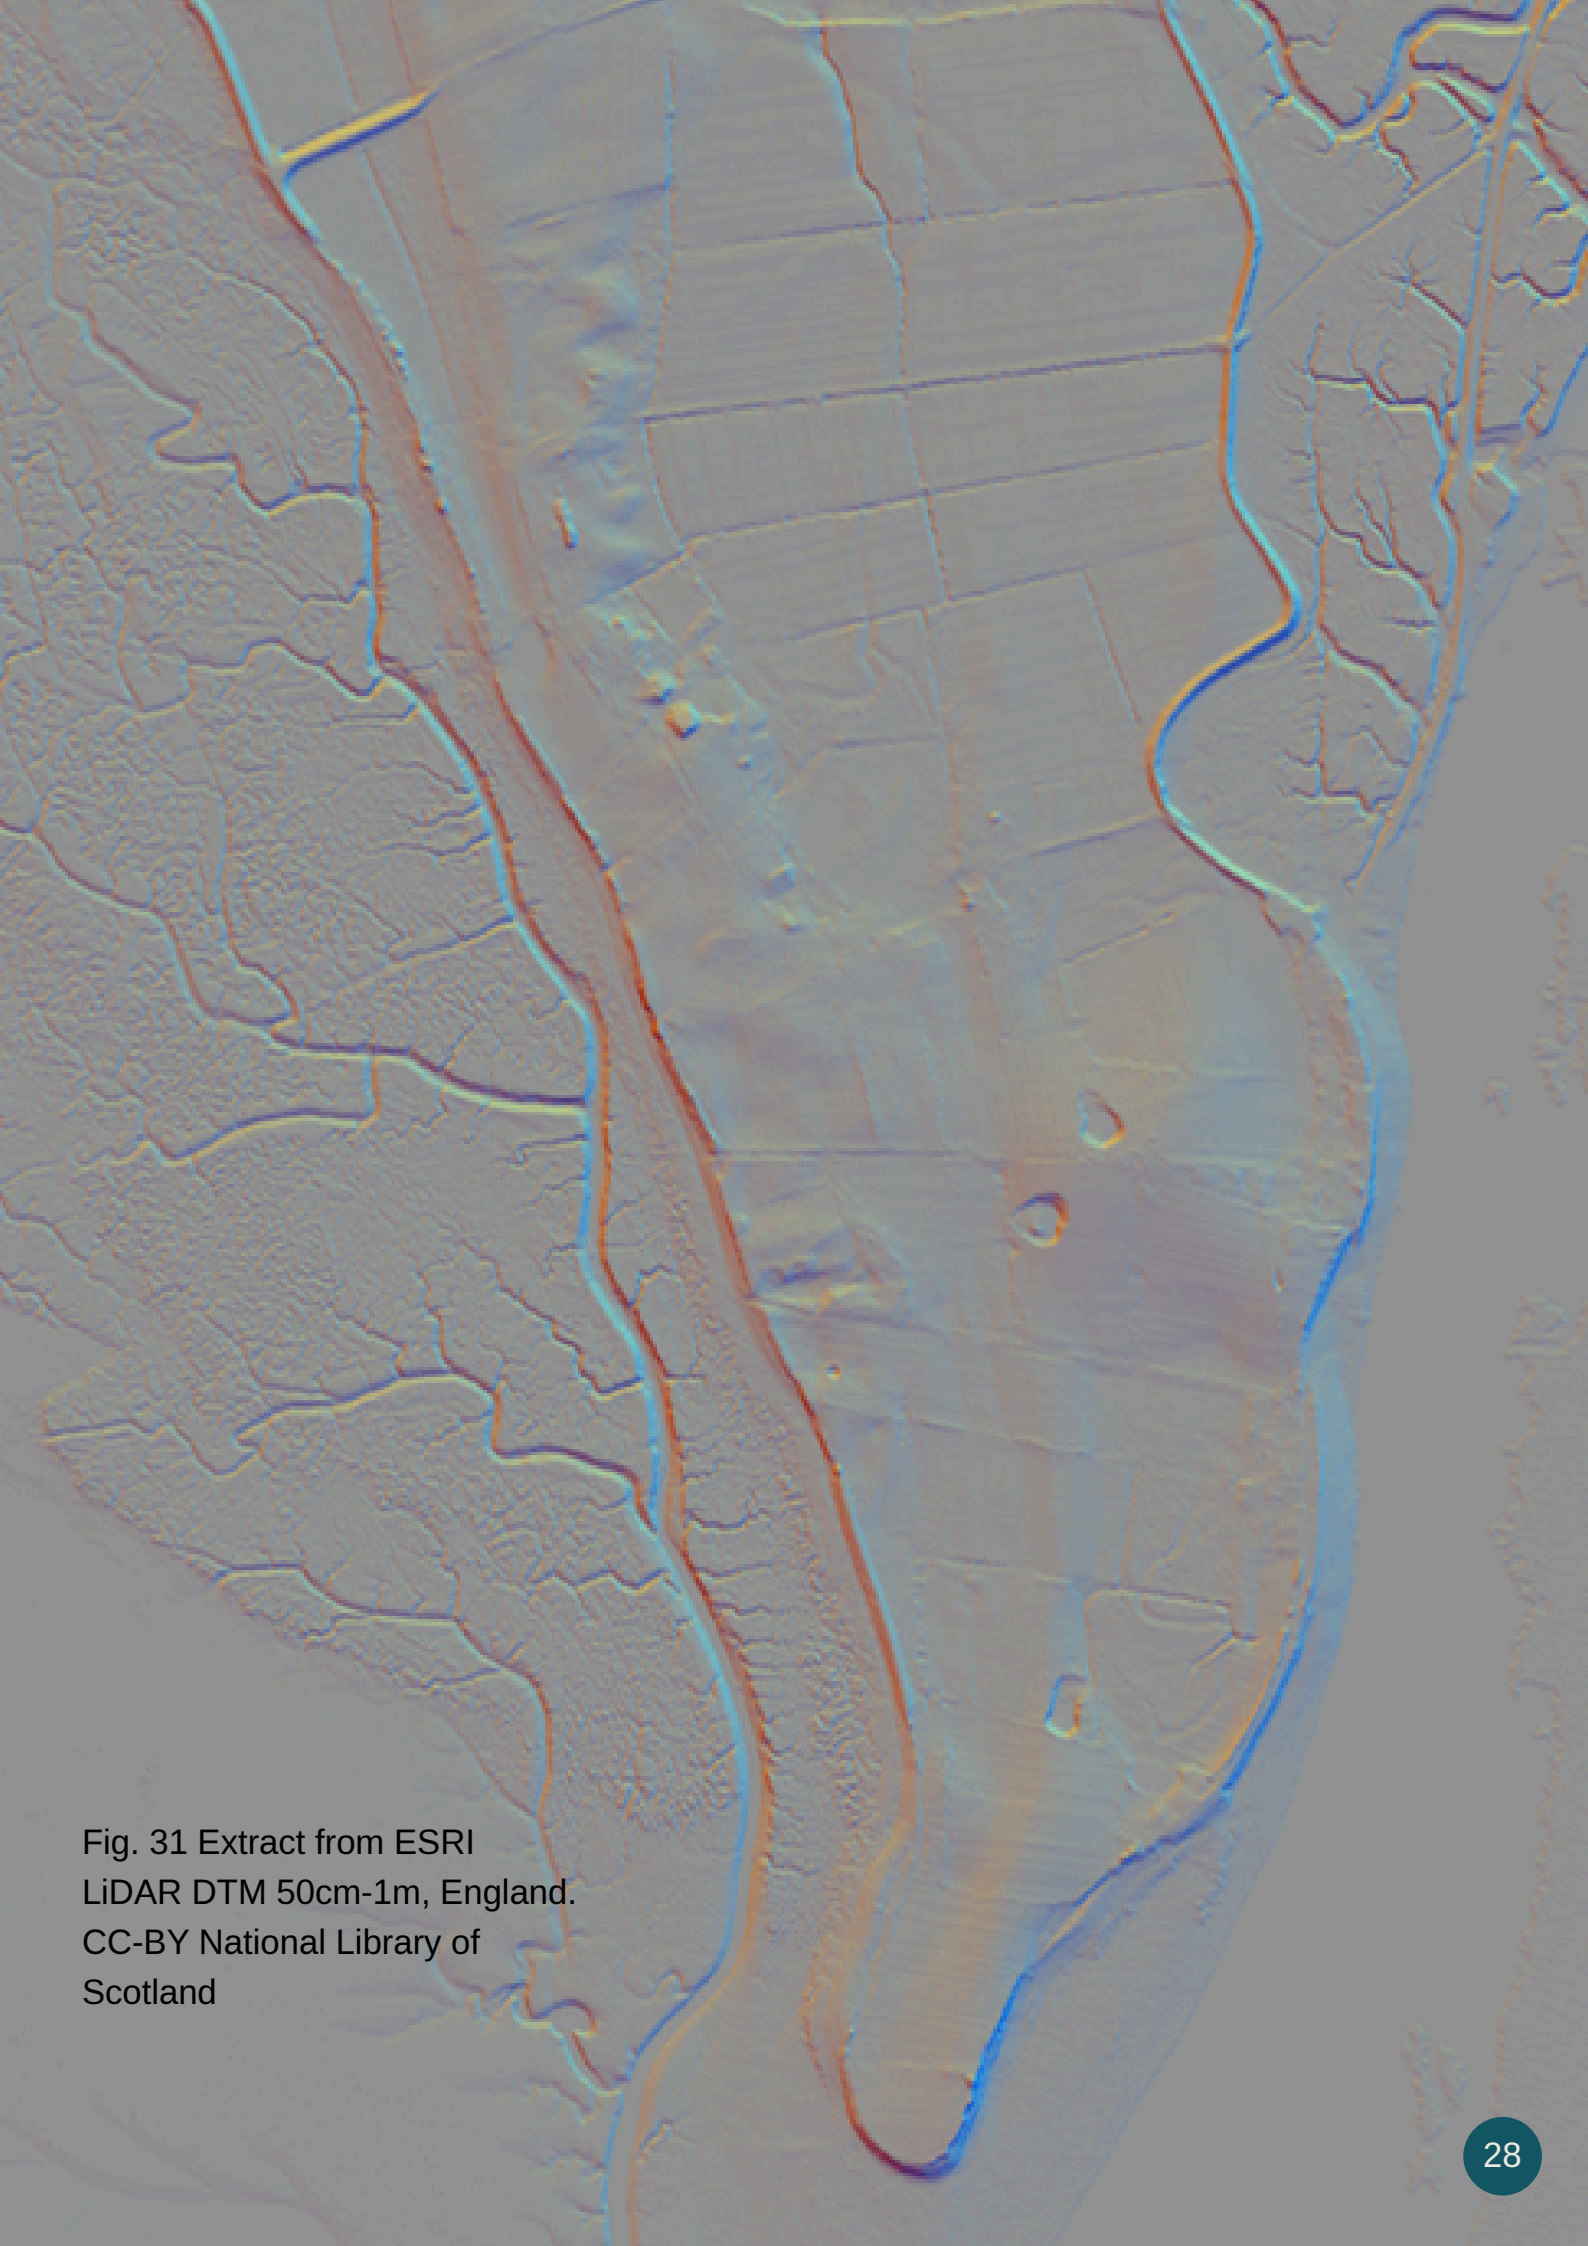
Fig. 31 Extract from ESRI  
LiDAR DTM 50cm-1m, England.  
CC-BY National Library of  
Scotland

These patterns suggest that all but the very highest parts of Sunderland Point were once wetland and that sea level rise or failure of the embankments could make them so again.

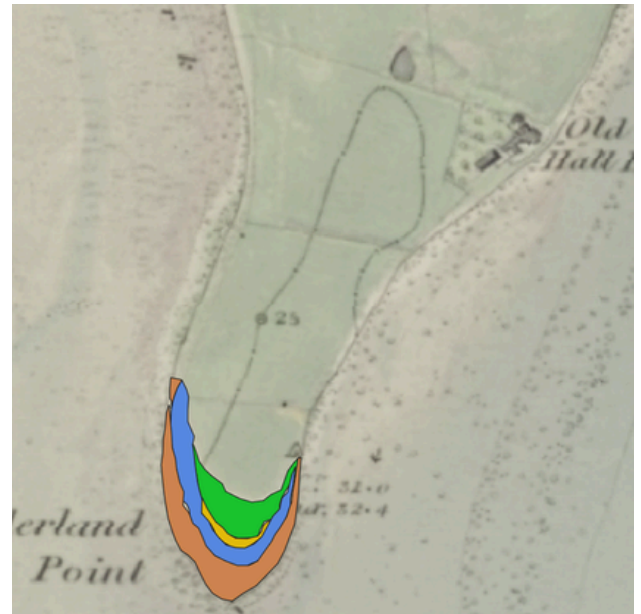
Fig. 32 Extent of land loss shown on historic mapping overlain on Six-inch England and Wales, Lancashire Sheet 34, Surveyed: 1844 to 1845, Published: 1848 and Google Earth imagery CC-BY National Library of Scotland.

Since 1848 approximately 8,359 m<sup>2</sup> of land, just over the area of a football pitch, has been lost from the end of Sunderland Point. As houses have not been directly affected by this loss it has not been prioritised for protection by external agencies. However, as well as being valuable farmland, it is possible that Point End provides a barrier to storm surges entering the estuary, and further losses could make the village more vulnerable to flooding.

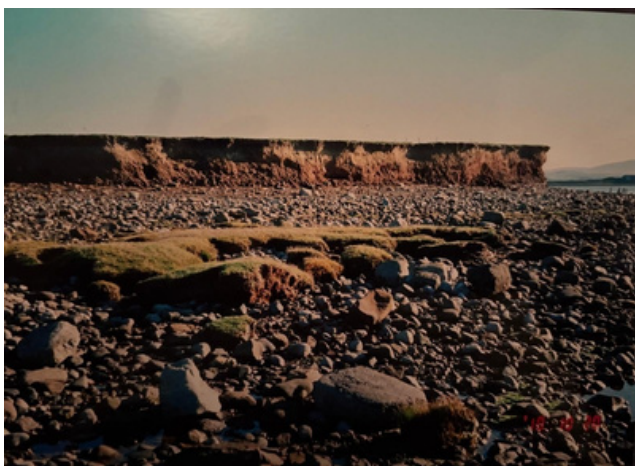
Fig. 33 Erosion of Point End in 2010 before installation of rock armour. Courtesy of Katharine Green.

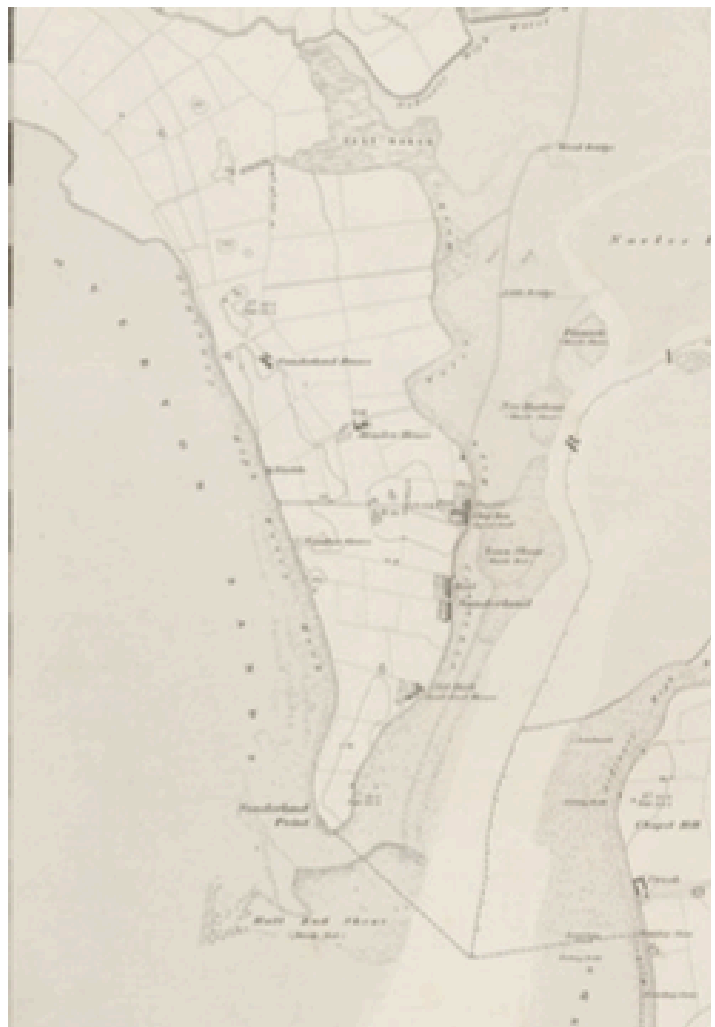
Fig. 34 Ordnance Survey, Six-inch England and Wales, Lancashire Sheet 34, Surveyed: 1844 to 1845, Published: 1848 CC-BY National Library of Scotland

It is likely that the late 19th century erosion of the point was related to changes in the shape of Hall End Skear (see figs. 34 and 35). It is unclear whether the point and skear were both damaged by the large storm surges which caused flooding in the village, or whether human interference with the skear left the point vulnerable to wave action.

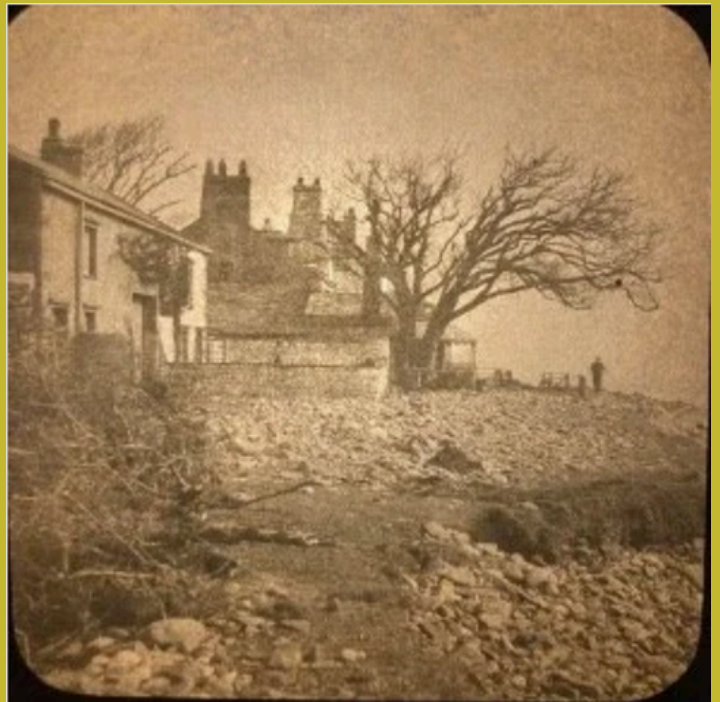
Fig. 39 Photograph of the aftermath of the flooding of 21-23 Second Terrace in 1907. Note that the area in front of the houses was grass before the flood. Gilchrist Collection.

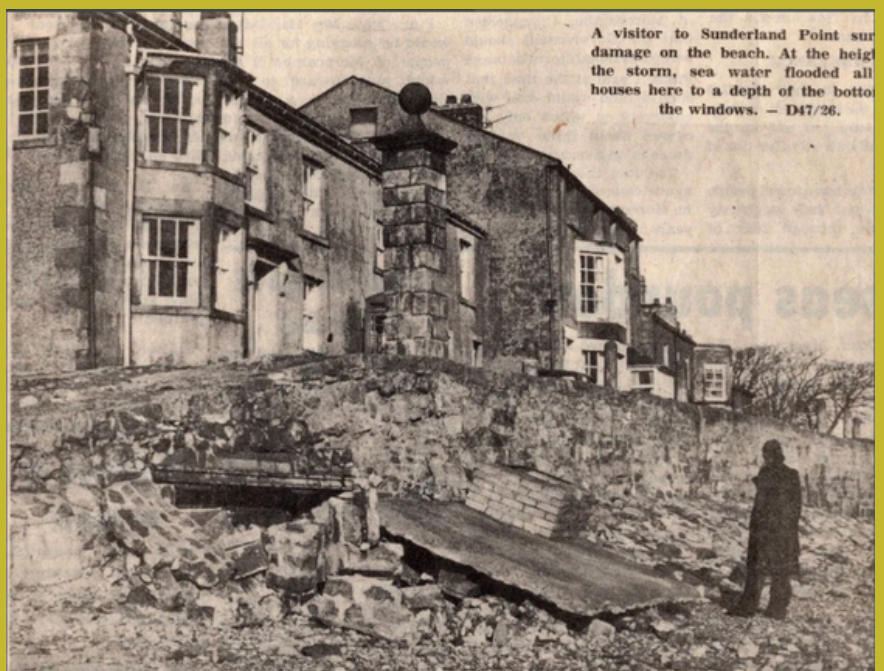
Fig. 40 Image from a newspaper article showing some of the damage of the 1977 flood. The Visitor, Flood of 1977 : Courtesy of Guardian Newspapers via [sunderlandpoint.net](http://sunderlandpoint.net)

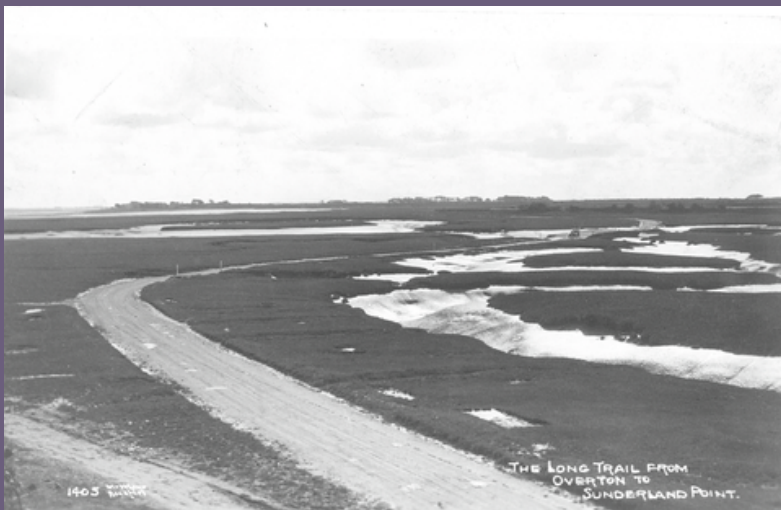
Fig. 43 Postcard showing the tidal road in the midst of Lades Marsh c.1930. Height of the saltmarsh much lower than today. Lancashire County Council Red Rose Collection NLA29012009001

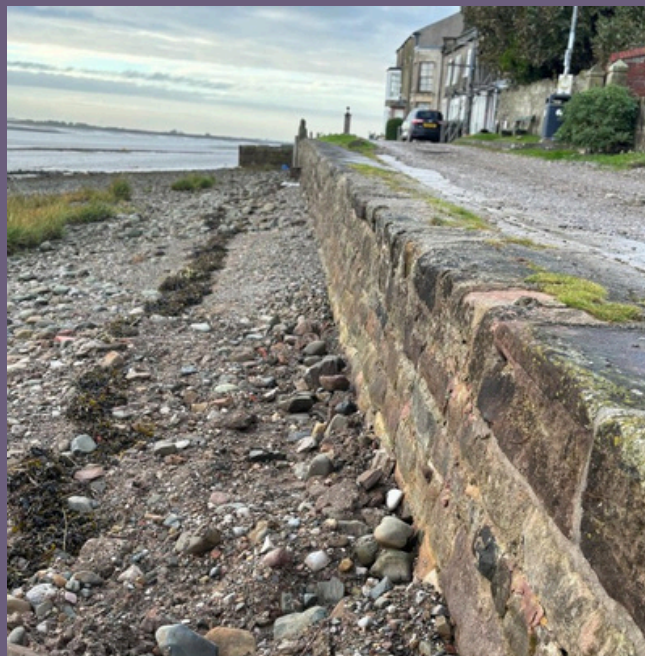
Fig. 44 Photograph looking south along the wall at First Terrace, showing grass growing in the shingle, 2024. Courtesy of Katharine Green.

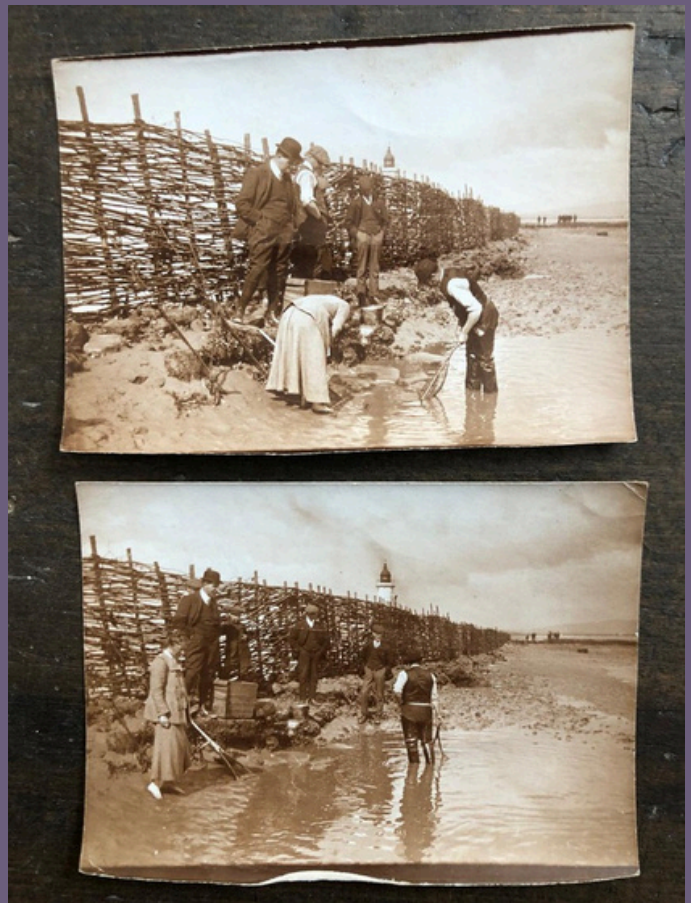
Fig. 47 Photograph of fishing baulk at 'new' Plover Scar lighthouse. Undated, post 1847, pre 20<sup>th</sup> century. Courtesy of Lizzie Gilchrist.
